# Structural Compatibility Test of M61 Gun/Linkless Feed Subsystem and F-105D Aircraft

APGC Technical Documentary Report No. APGC-TDR-62-57

OCTOBER 1962 • APGC Project No. 306A716

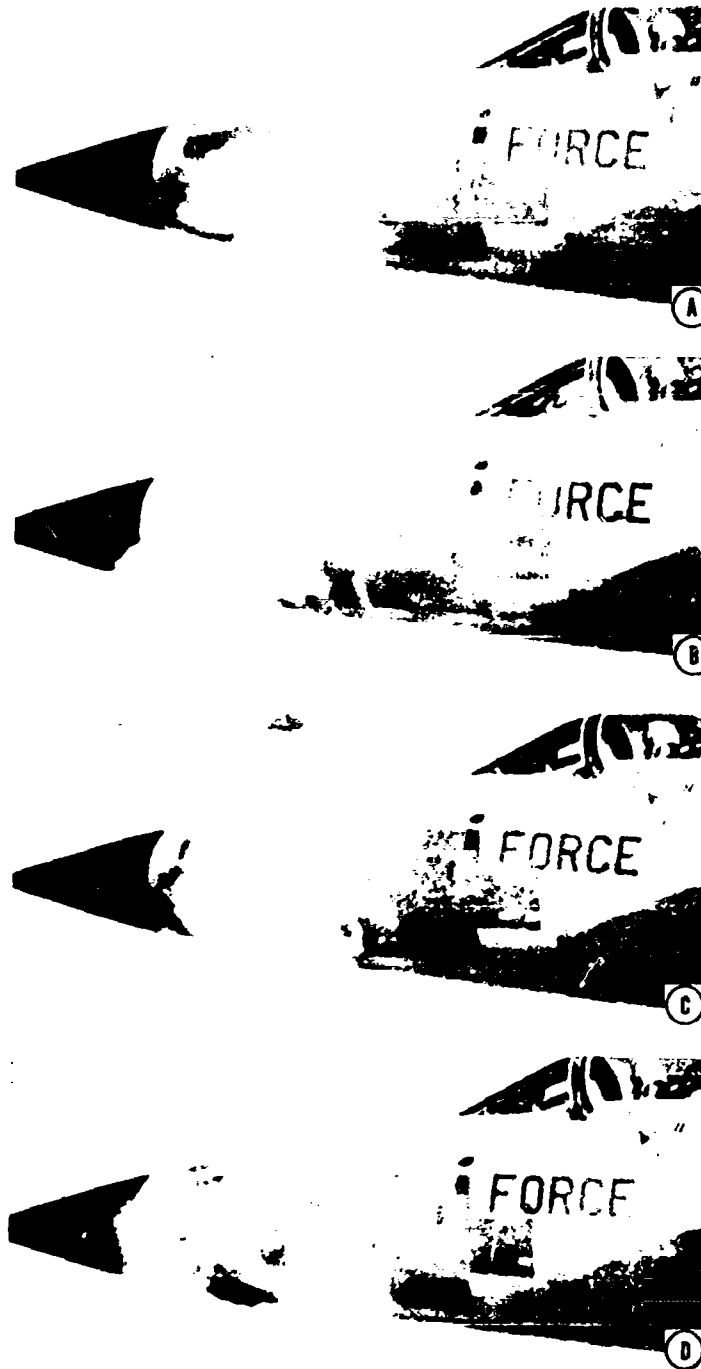
**Fig. 3:** Typical Flame Pattern Sequence, Showing (A) Ignition, (B) Burn, (C) First Stage Dissipation, and (D) Second Stage Dissipation.

**EXPANDED FLAME PATTERN.** An operational peculiarity was apparent during the test; this was the appearance of an expanded flame pattern (Fig. 3). This pattern, which is roughly elliptically-shaped (8 ft on the major axis and 4 ft on the minor axis), is caused by a mixture of gun gases and air. The flame pattern, sometimes coupled with engine surges, limited itself to a dynamic pressure range ( $q$ )\* of 405 lb/ft<sup>2</sup> to 926 lb/ft<sup>2</sup>, although it occurred randomly within this range.

There was no aircraft damage attributed to this flame pattern; however, the pattern was of sufficient intensity to distract the pilot during daylight flights and, therefore, may be a major cause of concern during night aerial-firing missions.
